**GEOTECHNICAL ASSESSMENT REPORT**

**CITY OF CUMMING, GEORGIA  
HIGHWAY 20 SAWNEE TANK SITE  
SLOPE FAILURE  
CUMMING, FORSYTH COUNTY, GEORGIA**

**GeoSystems Project No. 22-2875  
April 5, 2023**

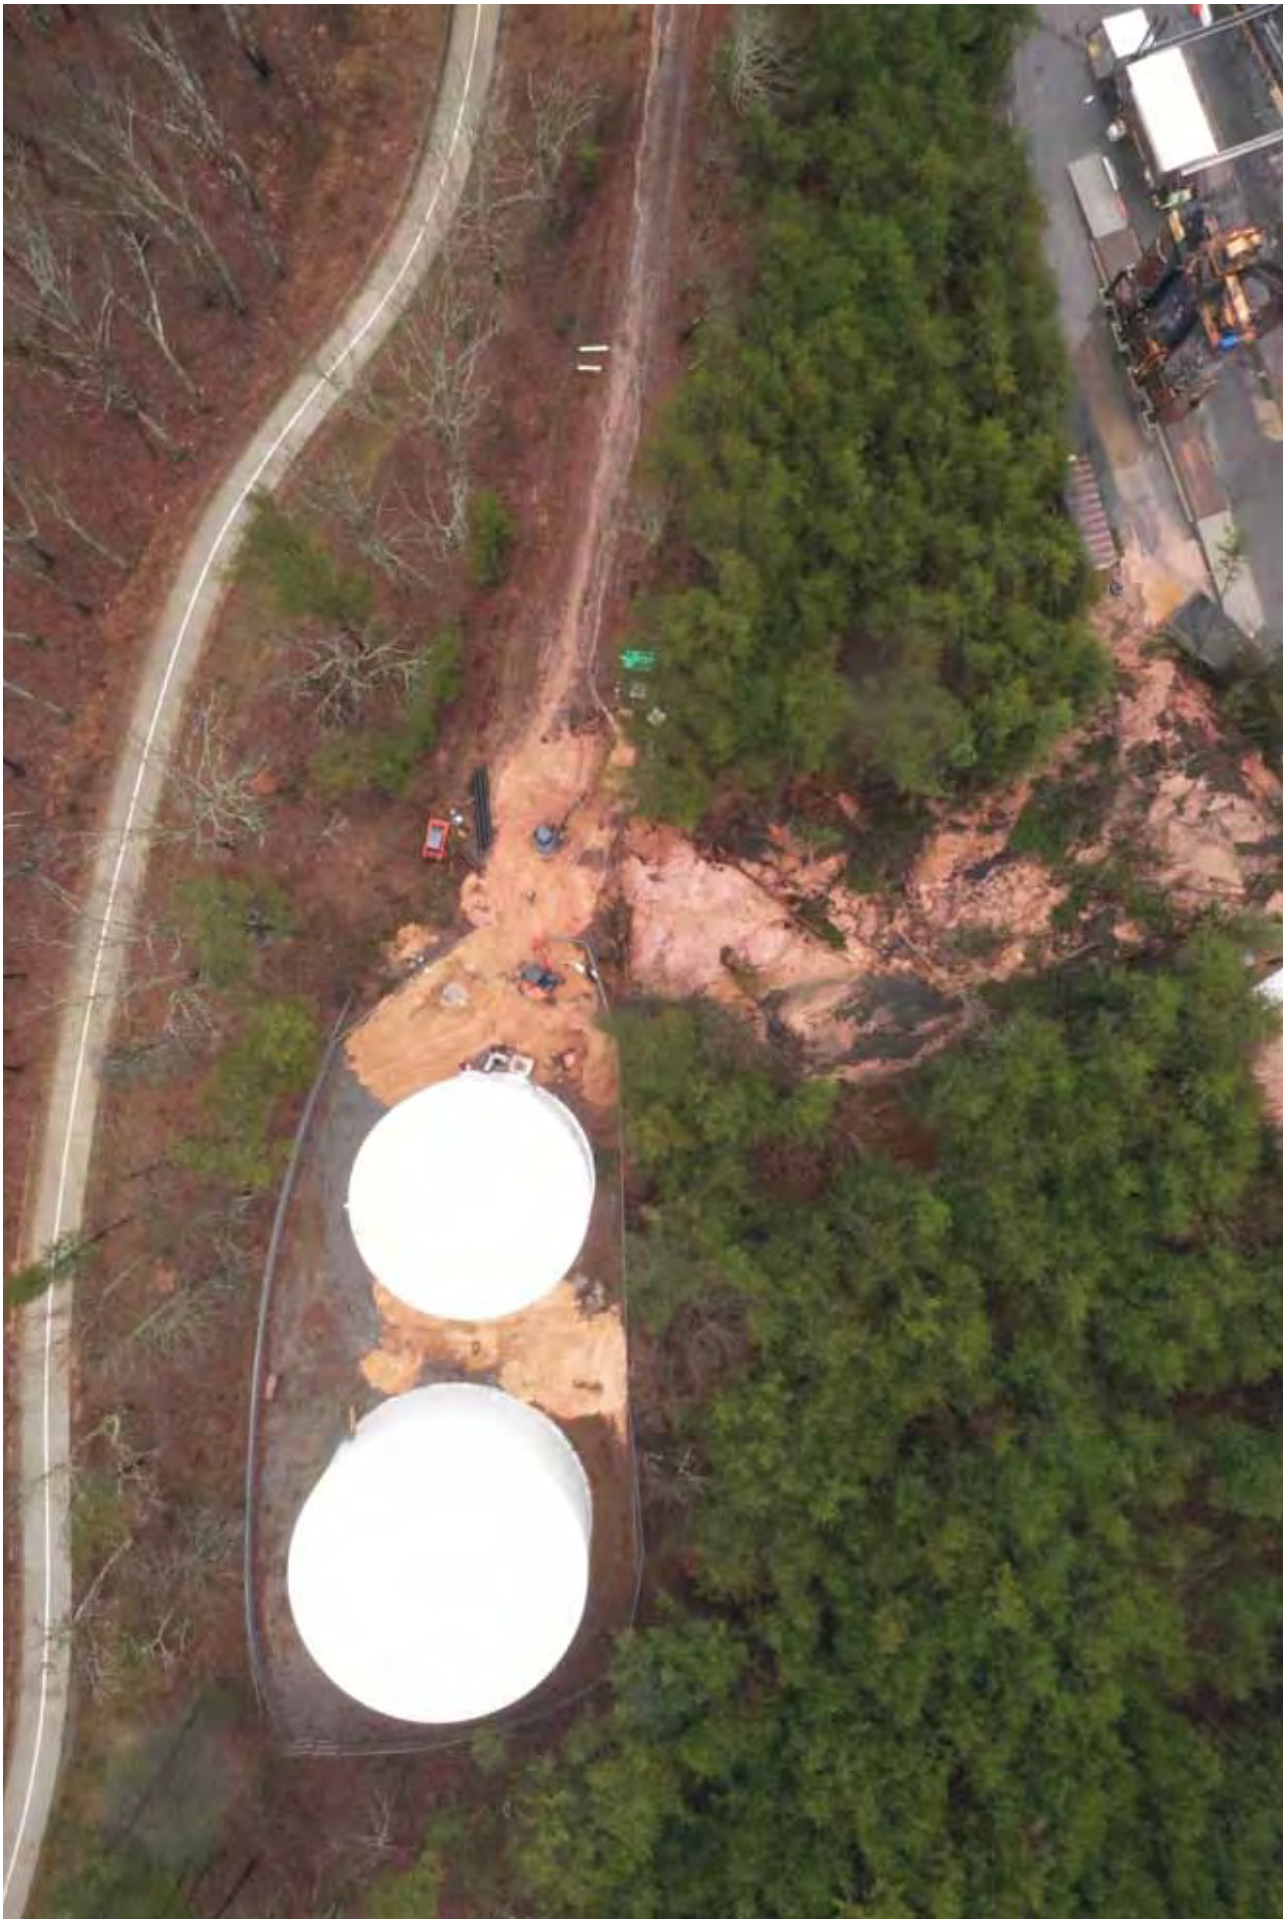
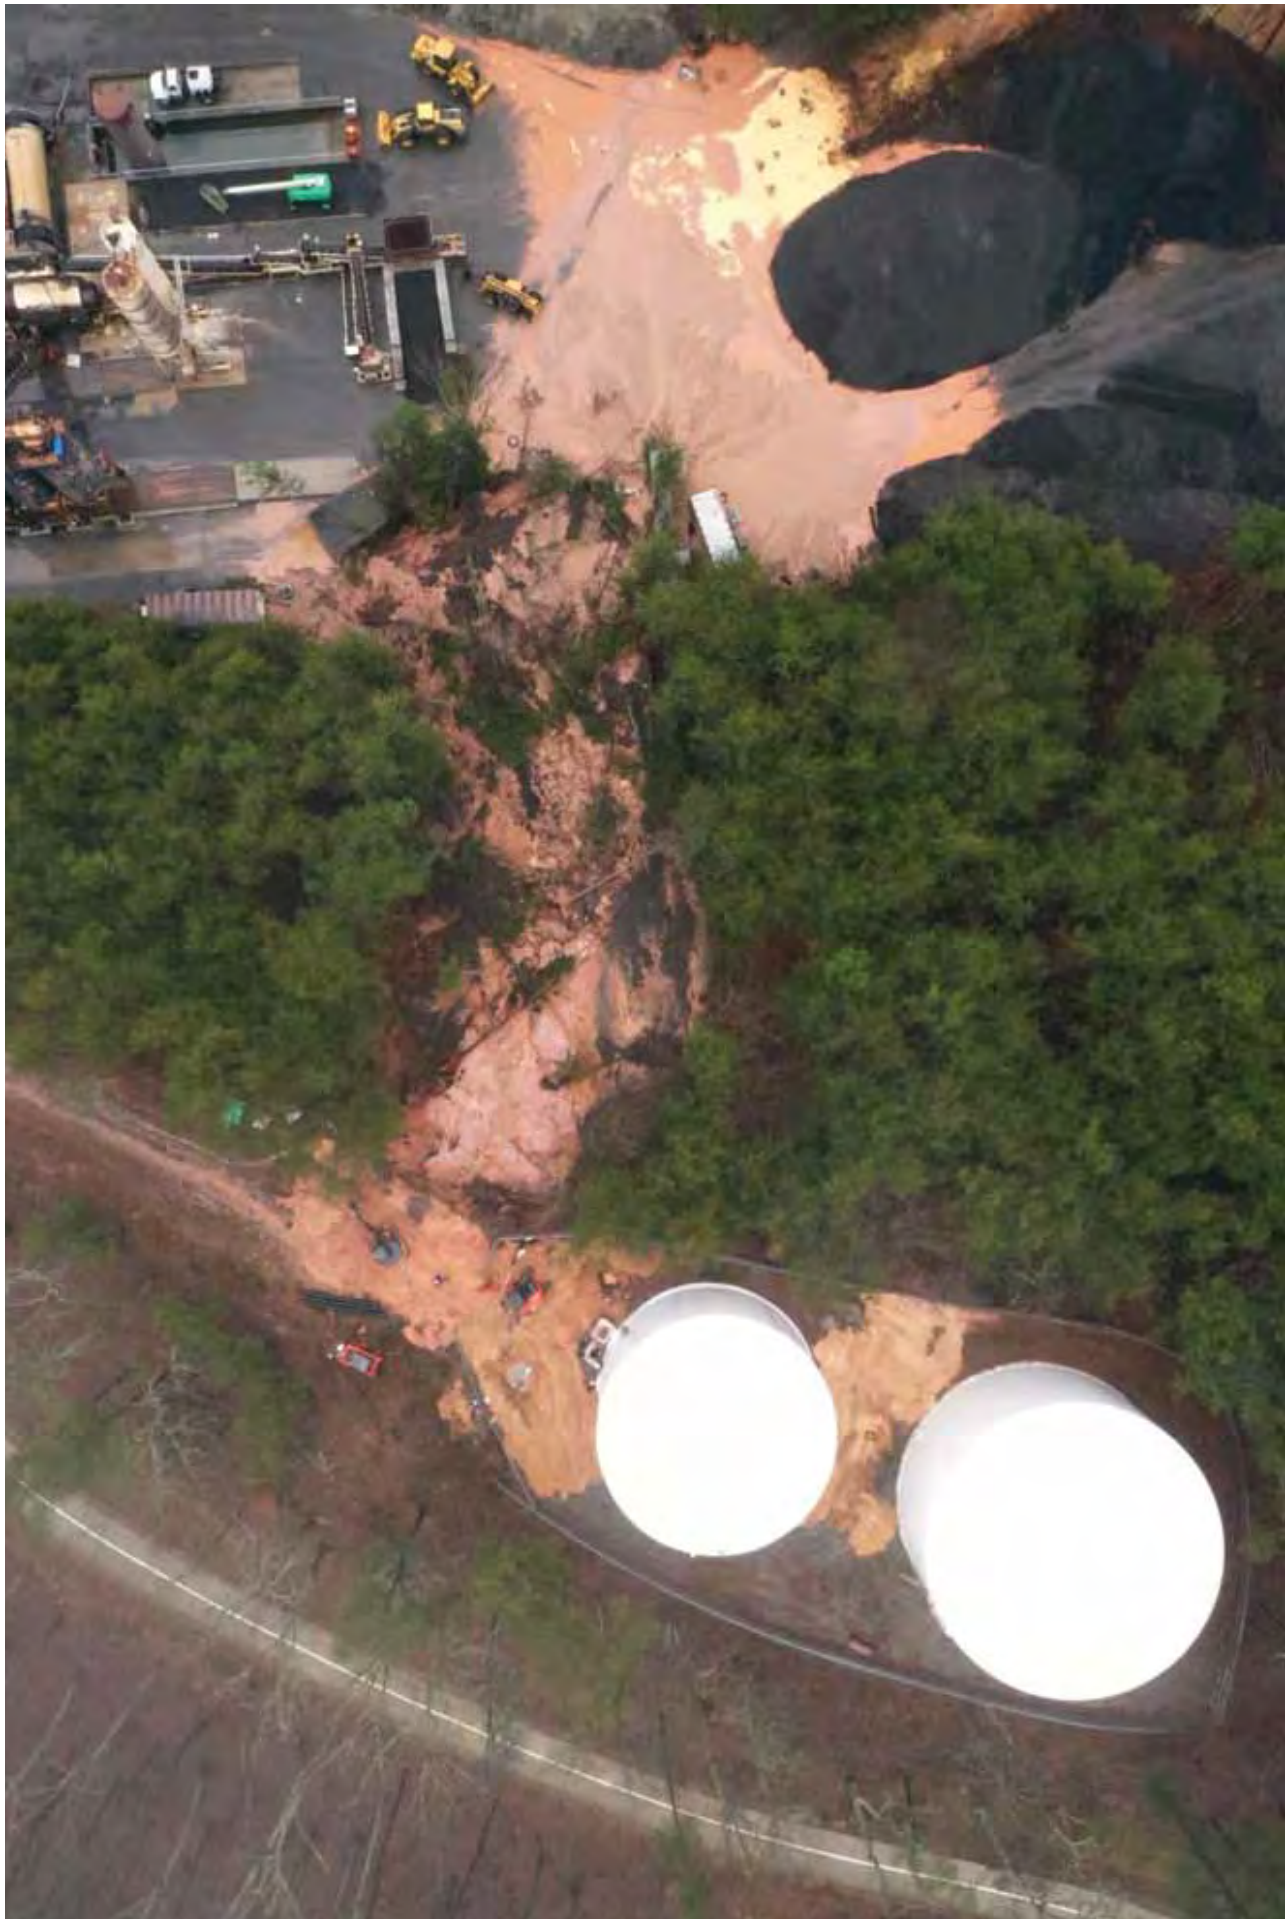
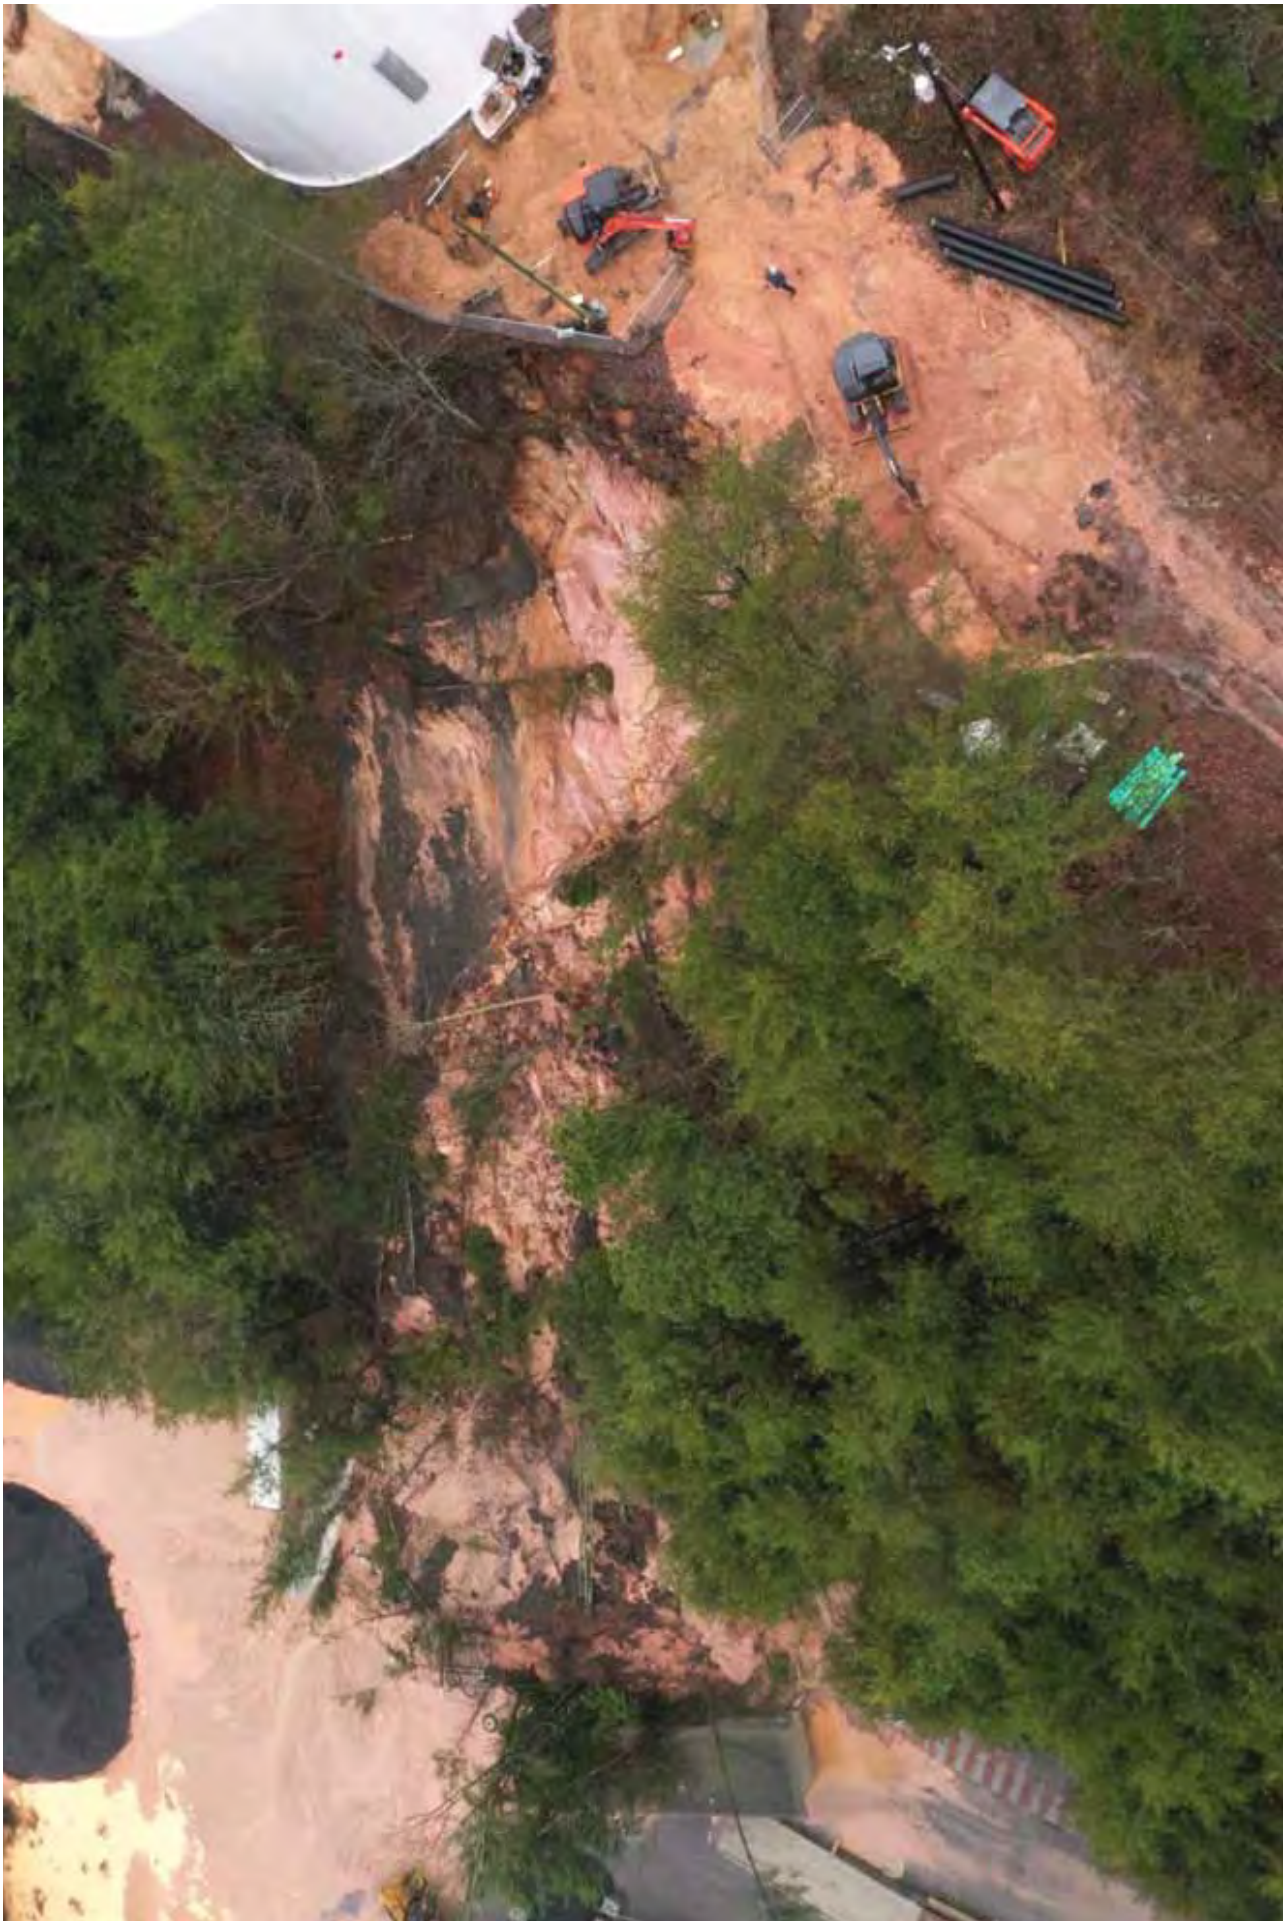
The massive slope failure that occurred at the site during the night of December 6, 2022, resulted in a large, relatively shallow scarp with translational movement that extended downward across the entire length of the hillside from the top of the slope to the toe. Joint separation of the water pipe serving the two tanks occurred during the failure and the contents of both tanks were discharged onto the slope. Mud and forest landside debris were deposited over the lower part of the slope and across the adjacent Blount Construction property beyond the toe.

Overburden soils in the upper portion of the failure were eroded and a very steep to near vertical scarp was formed in the underlying natural soils at the top. The scarp at the top of the slope was located 20 to 25 feet southeast of the 500,000 gallon tank. Visual observation during our initial site visit indicated undisturbed residual soils, partially weathered rock (PWR) or rock conditions were exposed in the failure scarp.

Drone Photo of Slope Failure on 12/09/2022

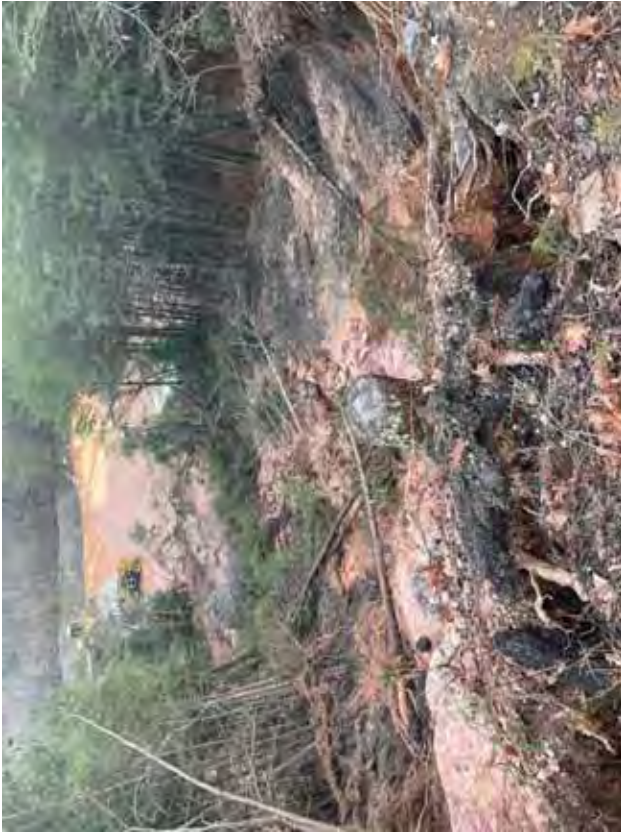
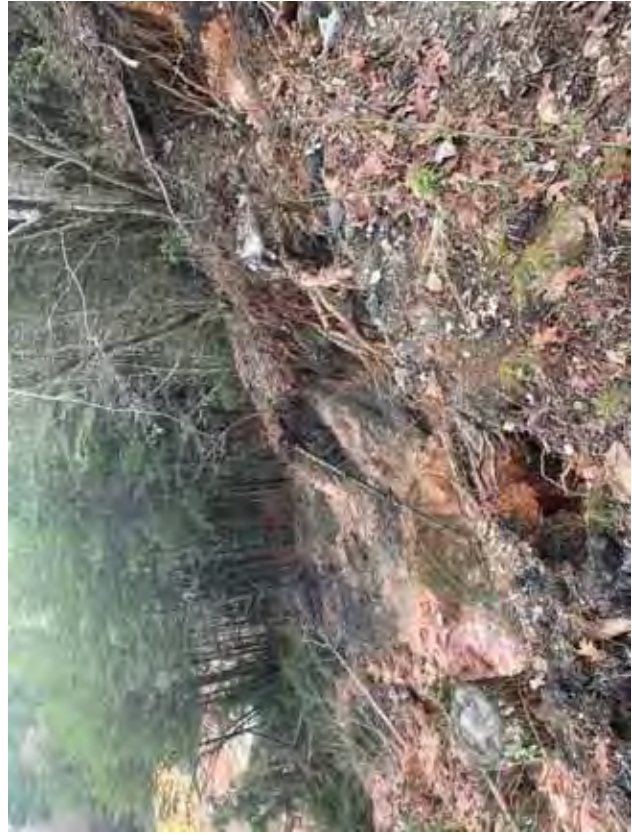
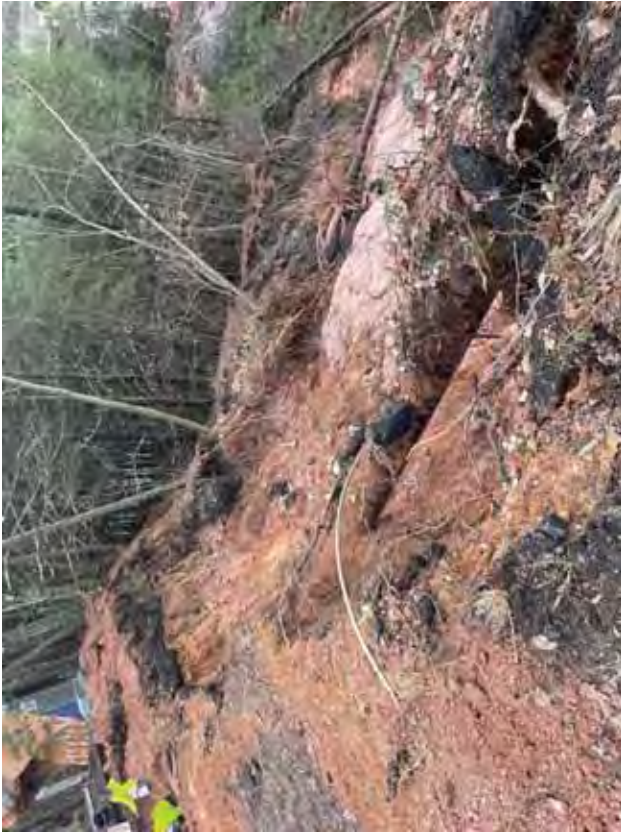
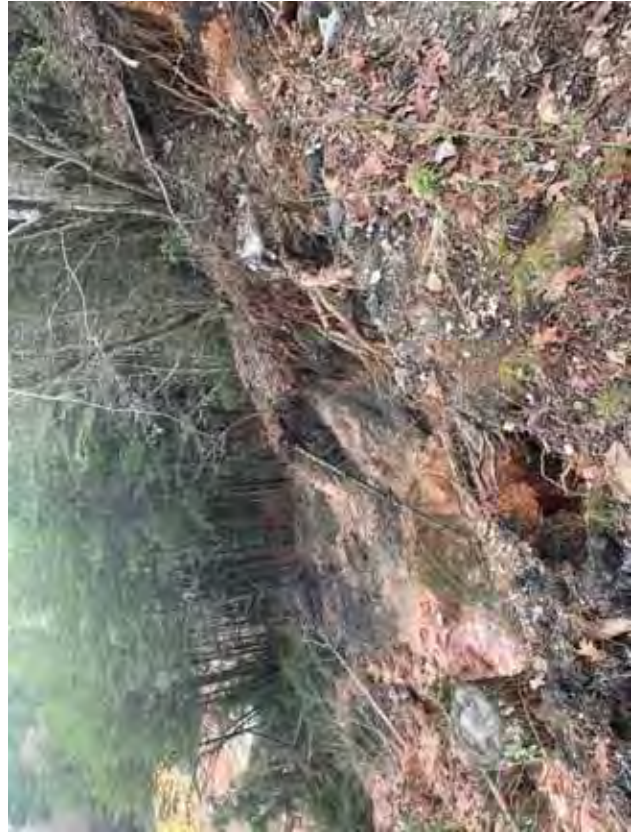
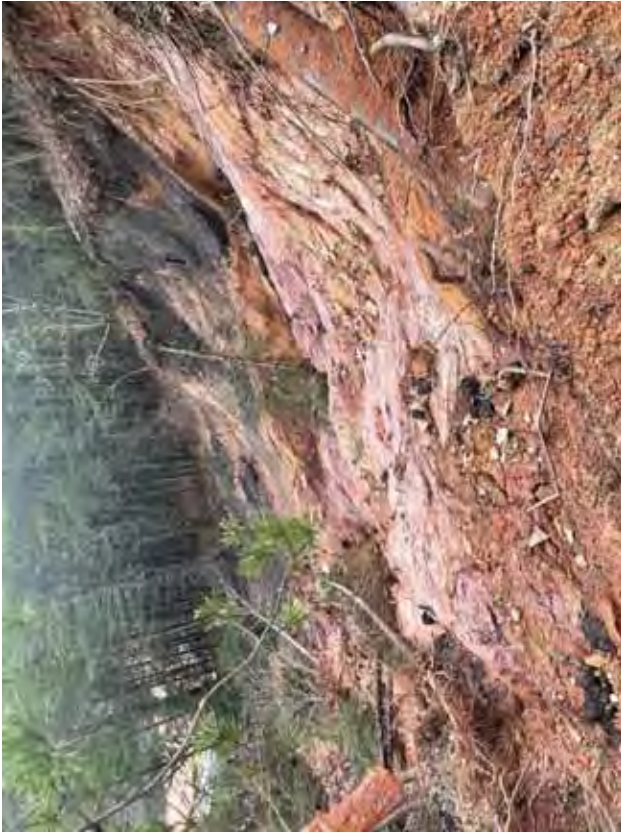
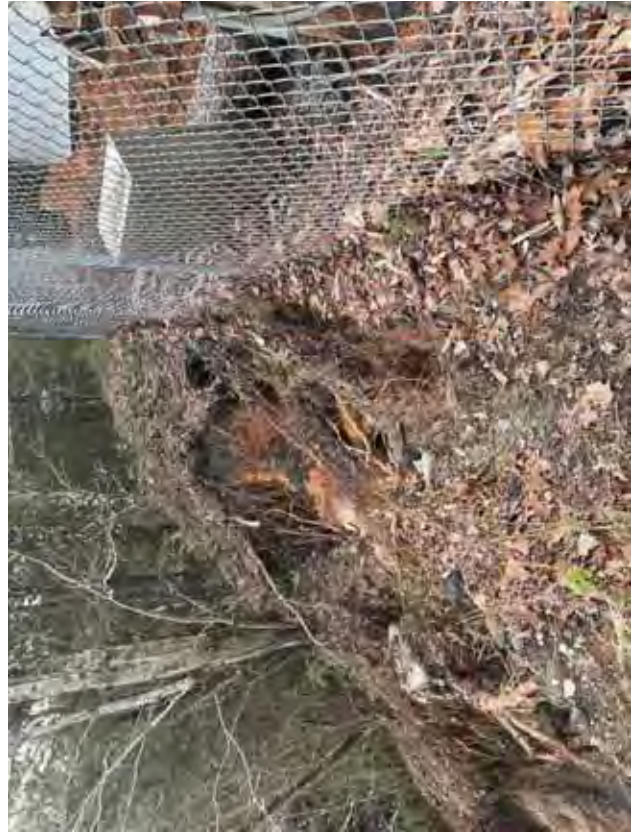
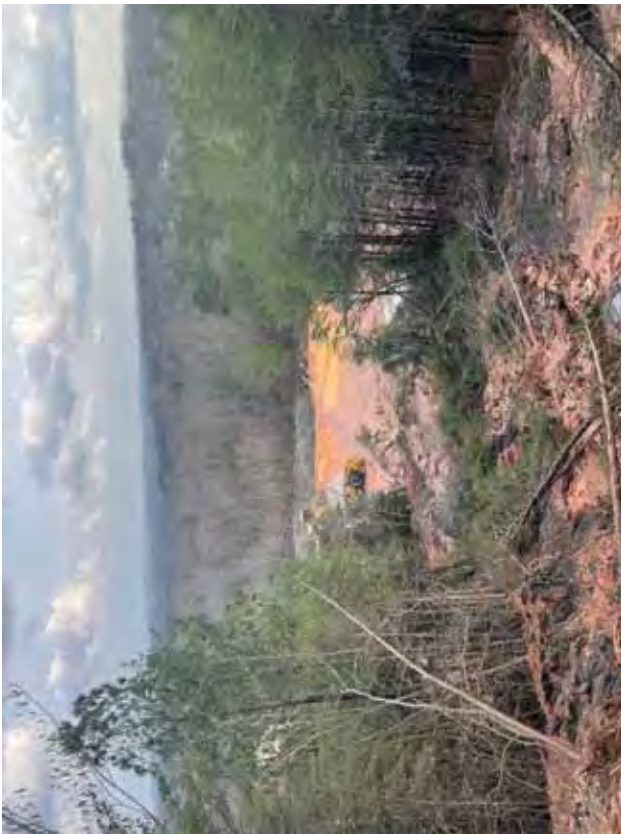
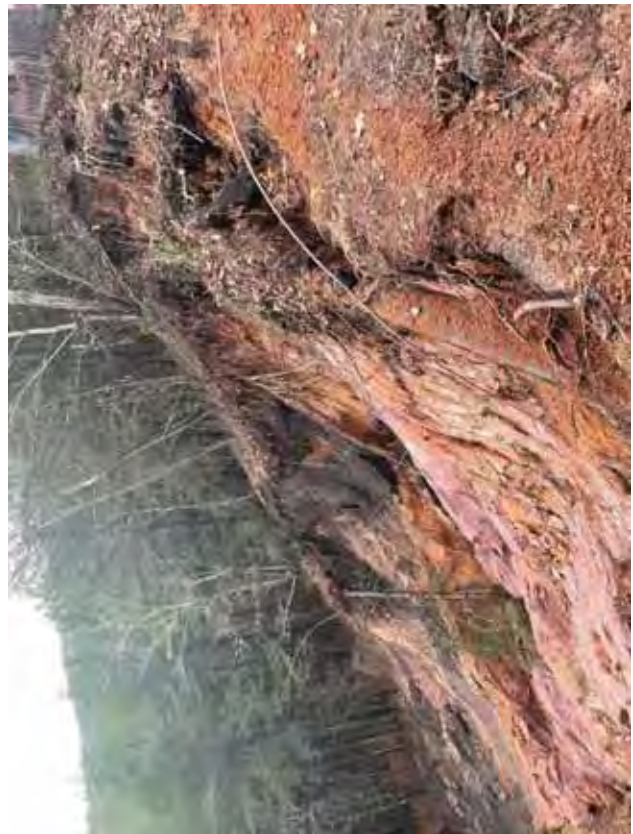
Slope Failure 12/08/2022

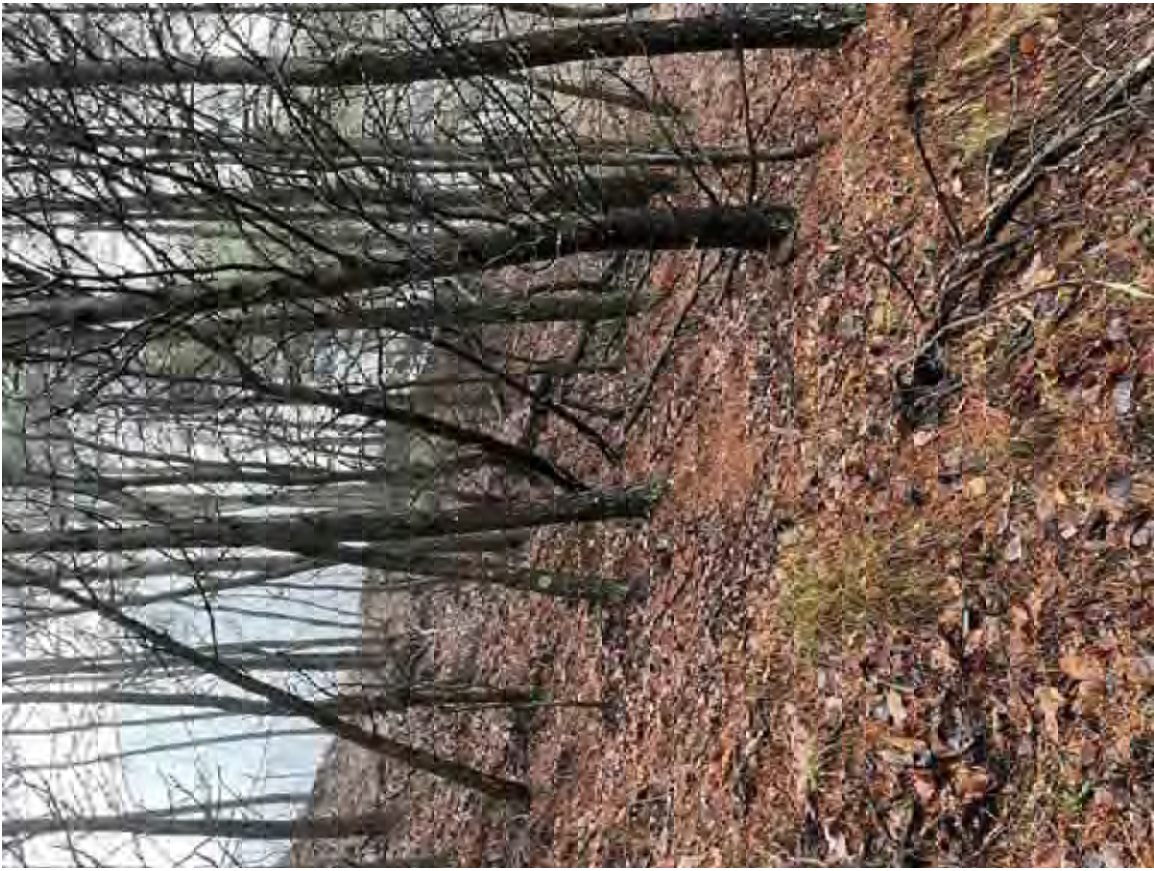
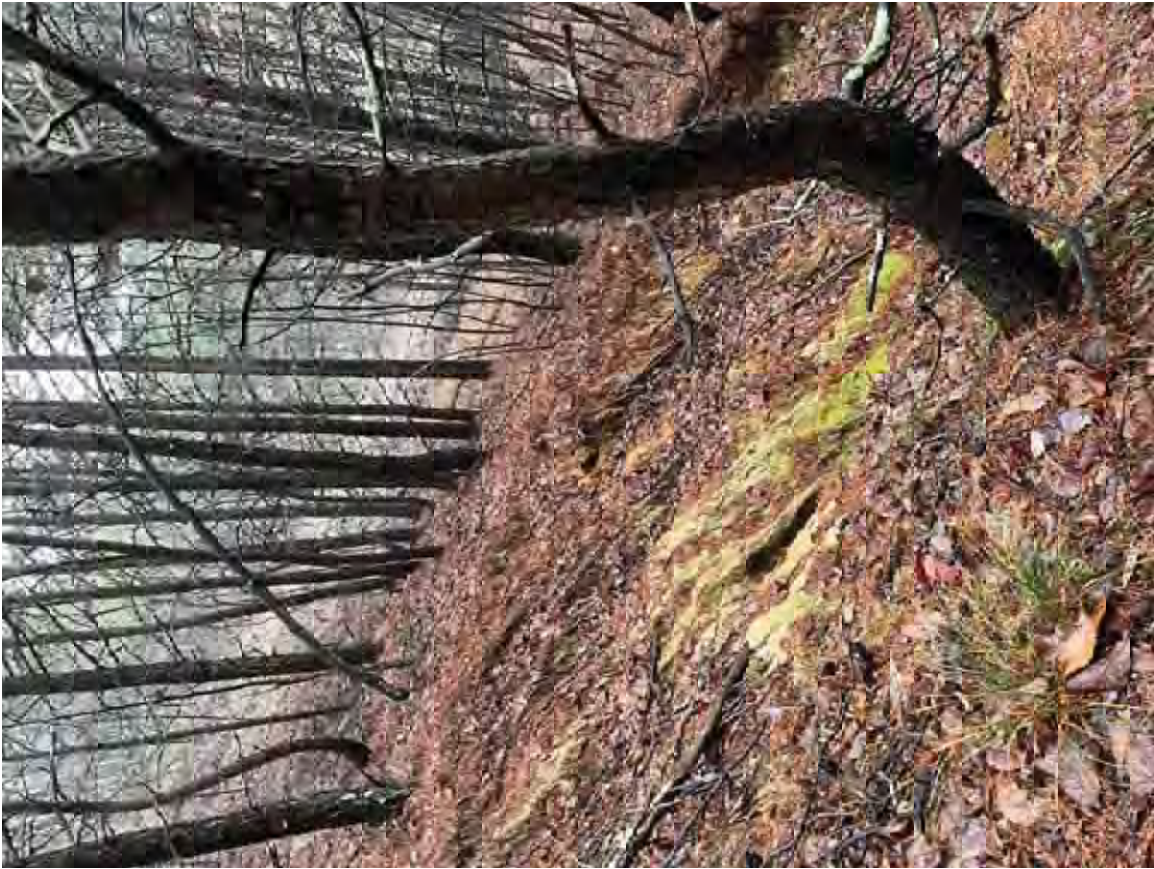
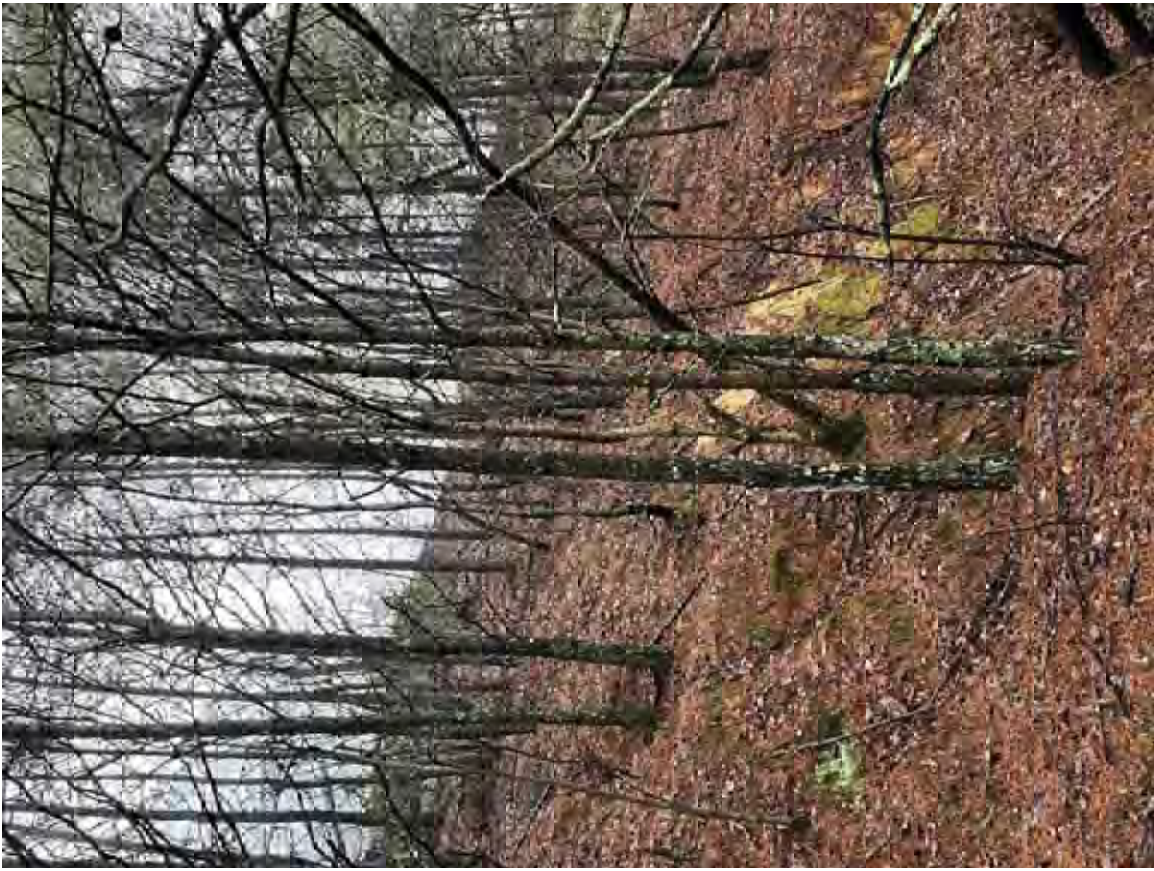
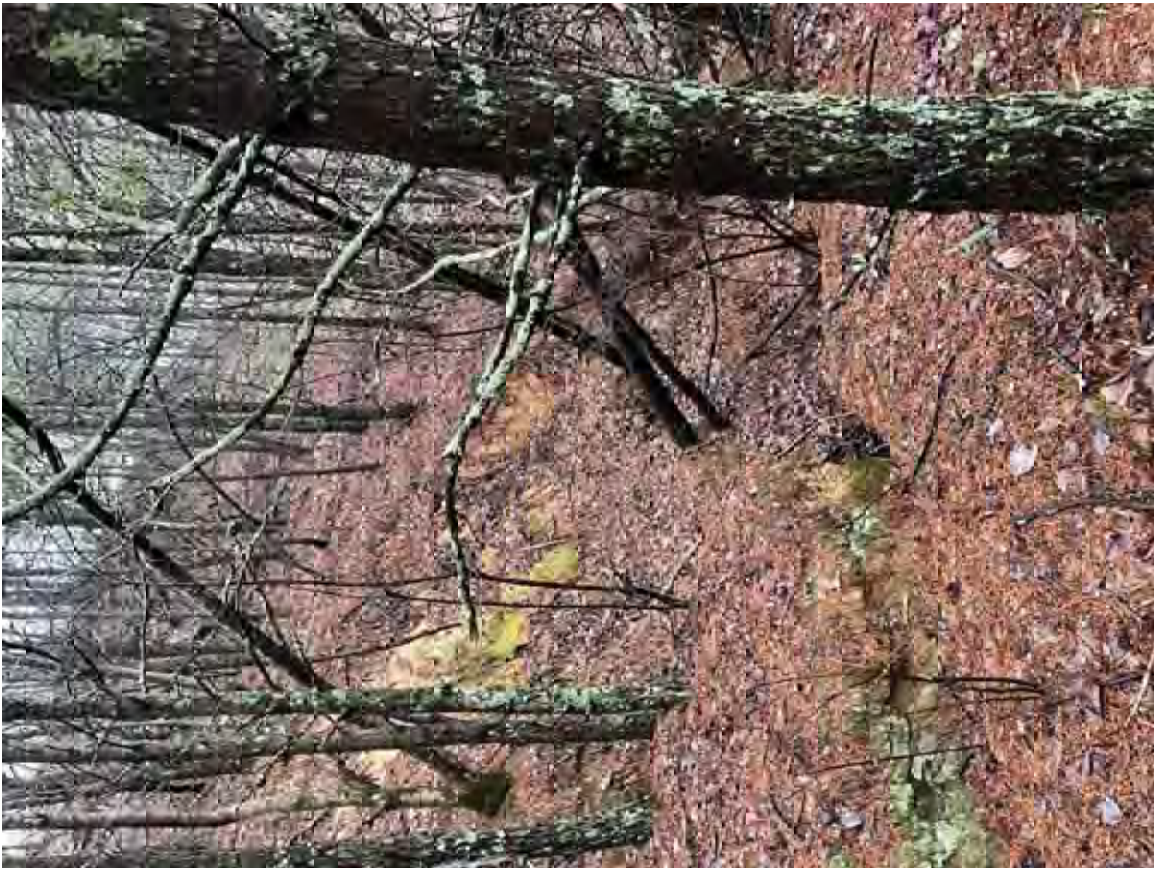
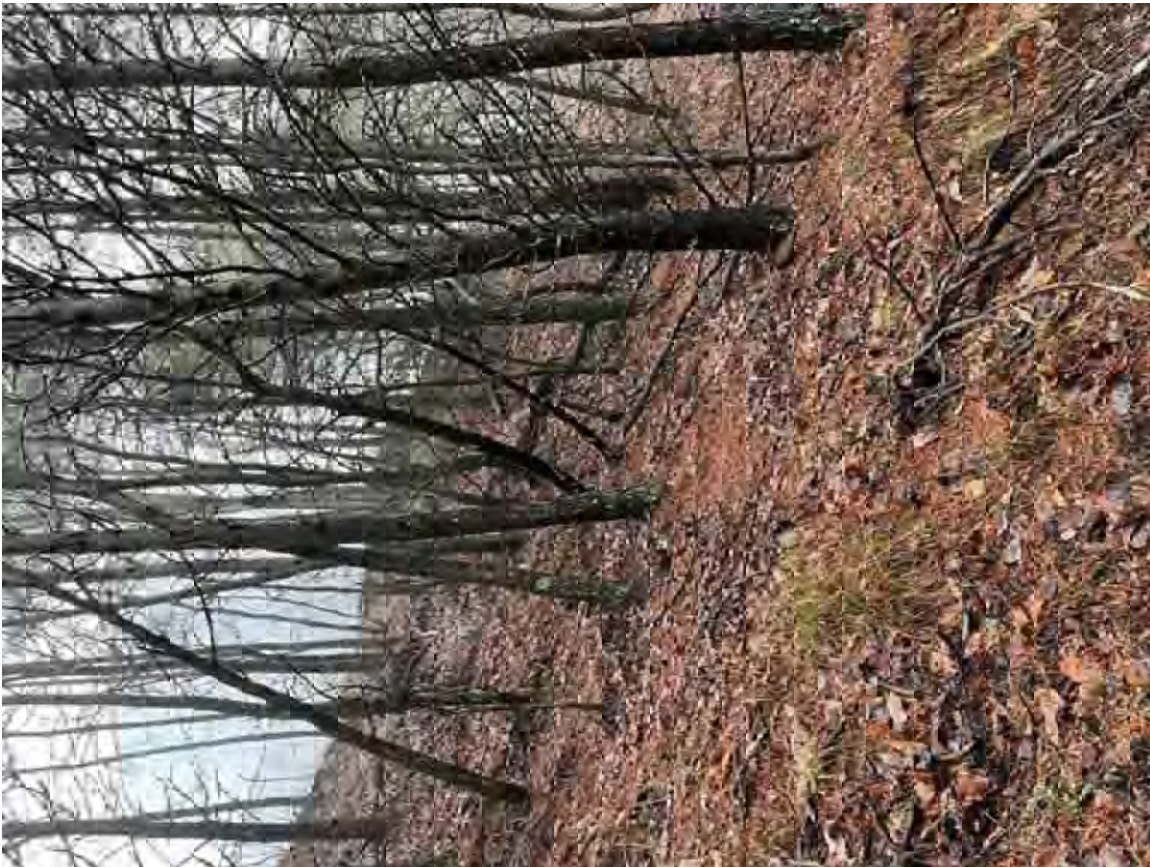
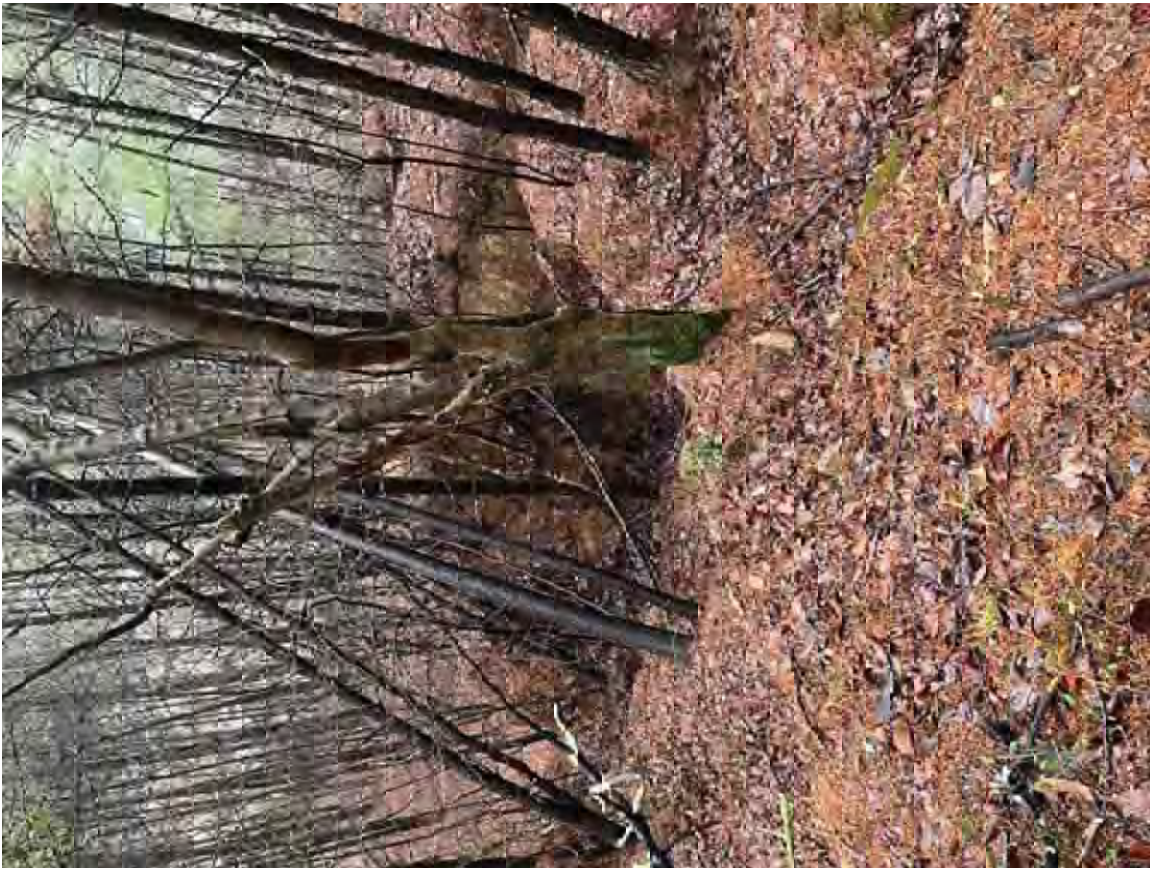
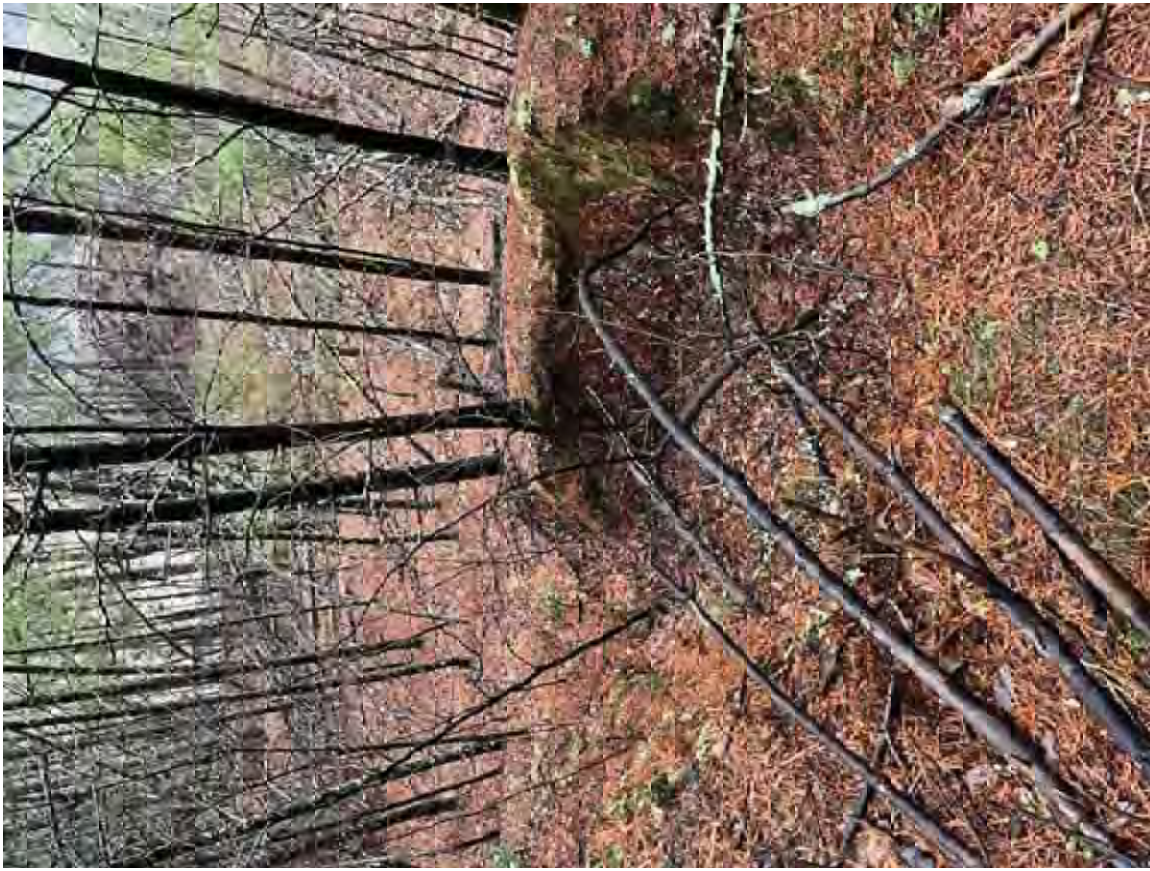
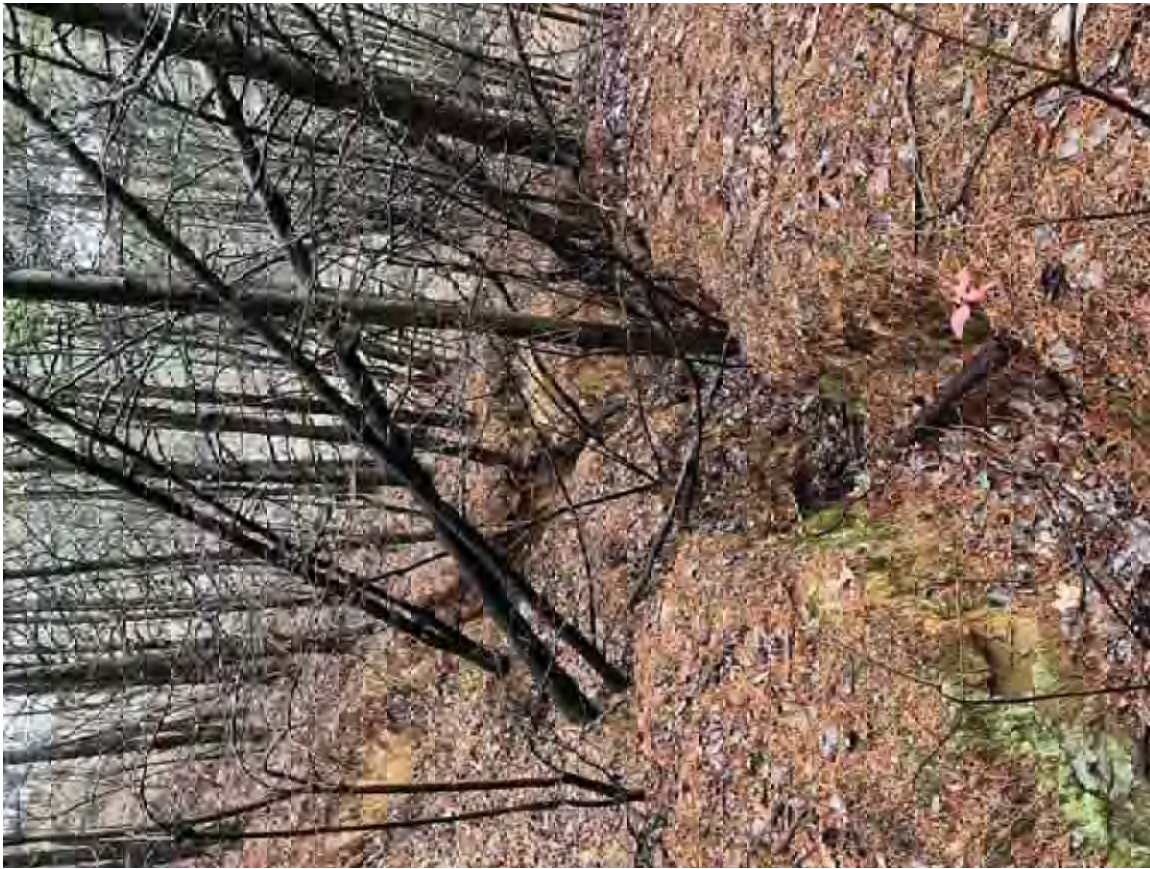
The slope on the southeast side of the existing tanks, southwest of the slope failure, is very irregular and broken up with benches, erosion gullies and various surface irregularities. The immediate slope below the tanks above elevation 1326 to 1330 feet generally varies between 60 and 80 percent ( $\pm 1.67$  to  $1.25H:1.0V$ ). The lower slope is somewhat flatter, with areas varying from about 25 to 70 percent. A relatively moderately sloping, 25 to 35-foot wide bench is located generally between elevations 1320 and 1330 feet along most of the lower slope but narrows approaching the existing failure scarp. Another smaller bench located between elevations 1302 and 1310 extends about 70 feet immediately southwest of the failure scarp. Total relief of the slope in this area is 92 to 94 feet, varying from high elevation of 1388 and 1390 feet at the tank pad to 1296 feet at the toe on the Blount Construction property. The top of the slope is located about 10 feet from the edge of the tanks. The southeast slope, northeast of the slope failure, appears more uniform with slopes varying approximately from near 100 percent ( $1.0H:1.0V$ ) at the top to 50 percent ( $2.0H:1.0V$ ) near the bottom. The average slope of the entire hillside appears to be 60 to 65 percent and the total relief is about 72 feet, varying from a high elevation of 1370 feet at the top to 1298 feet at the toe.

Our observations during several site visits show indications of long-term slope movements and instability of the southeast slope below the tank site. Small, relatively shallow, slope failure scarps and erosion gullies were observed at a number of locations along the slope face. During our initial site visit, following the December 2022 slope failure, surficial failure scarps were observed at the top of the slope directly below the existing water vault. The soil nail wall emergency slope stabilization measure completed by GSI was installed through the old scarps at that location. A somewhat larger scarp was observed on the slope between elevations 1340 and 1360, directly downhill of the tanks. A large erosion gully exists below this scarp. In addition to these features, tree growth on the slope indicates downhill movement or creeping of the hillside. The relevant tree growth includes curved trunks, straight trunks leaning downhill, toppled trees, and a significant number of dead trees falling over randomly about the slope. At least nine cast iron pipes and one steel beam were previously installed vertically into the ground along the slope below the tanks, apparently in an attempt to mitigate the slope movements.

Existing Slope Conditions Southwest of Failure 12/09/2022

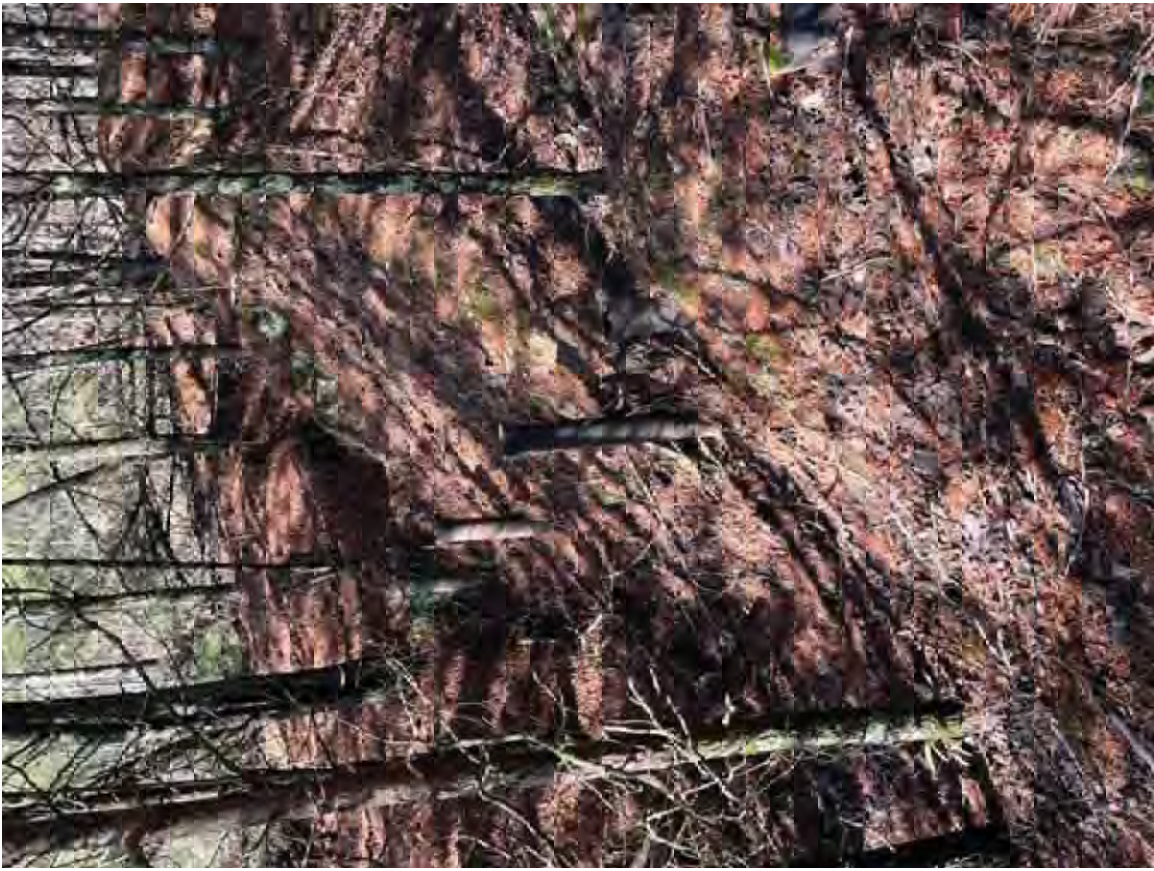
Cast Iron Pipes in Existing Slop Southwest of Failure 02/03/2023

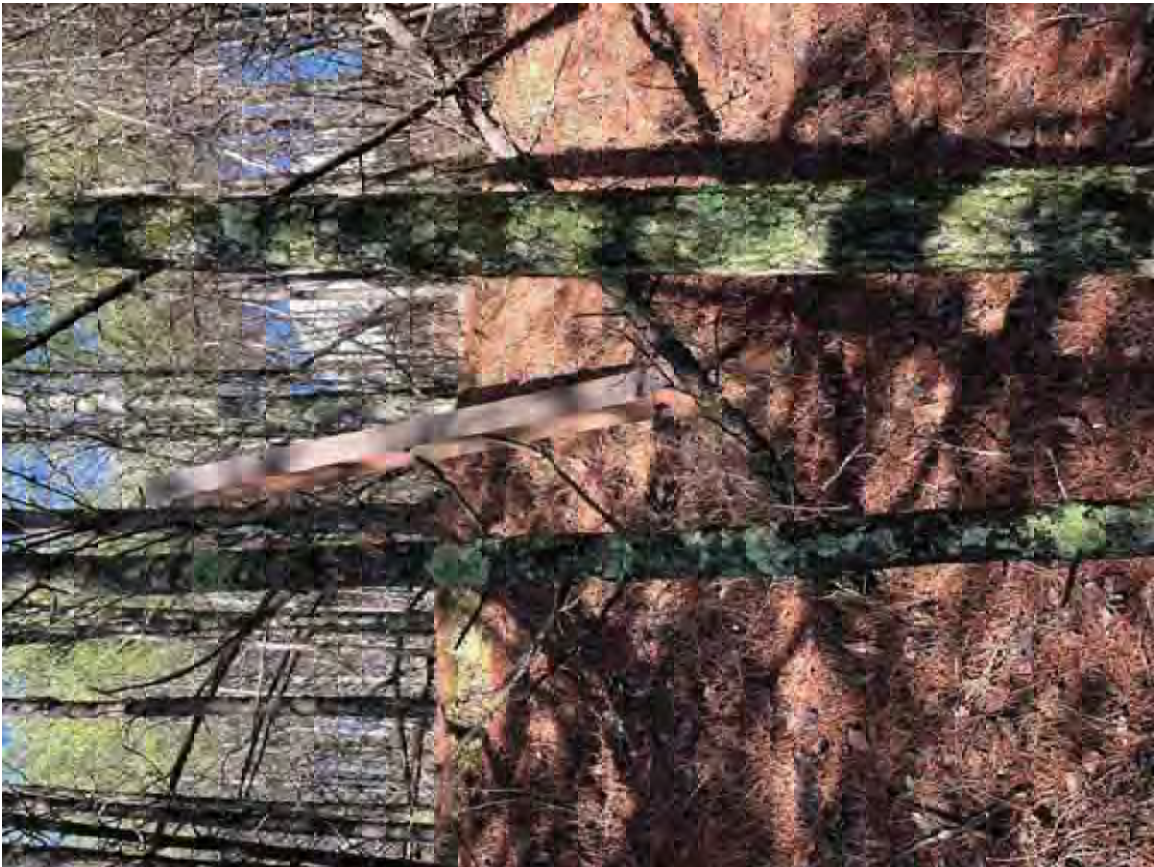
Steel Beam in Existing Slope Southwest of Failure 2/03/2023
